EMERGENCY MONITORING OF TAILINGS LEAKAGE BASED ON GEE PLATFORM

KEY WORDS: Google Earth Engine ; pollution monitoring; tailings pond leakage

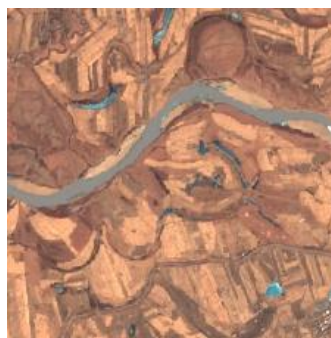
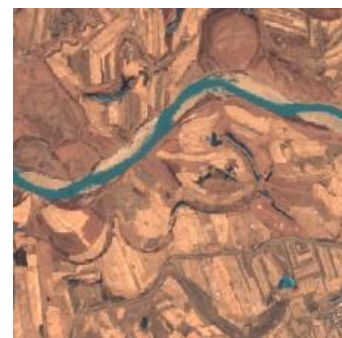
Figure 1: Images of Yijimi river near Xingfu reservoir before and after the accident

Image beside Xingfu reservoir
on March 29, 2020

Image beside Xingfu reservoir
on April 5, 2020

Image beside Xingfu reservoir
on April 10, 2020

In the remote sensing images of the two key interception points, it can be clearly seen that the gray pollutants never appeared in the Ejimi River, then flowed downstream and were finally intercepted at Lanxi Old Bridge. Through the observation of remote sensing images of key interception points, it is finally determined that the end point of pollution is at the interception point of Lanxi Old Bridge. The polluted rivers and districts and counties in this accident are shown in Figure 3:

After the 3.28 tailings leakage accident in Yichun, the leaked pollutants entered the Yijimi River and spread downstream along the river course. To clarify the impact of the pollution, the river course through which the pollution flows must first be determined. In this study, Sentinel 2 image with cloud cover less than 8% was selected on GEE platform to dynamically monitor several pollution interception points after the accident. Figures 1-2 below show the images of two key interception points :

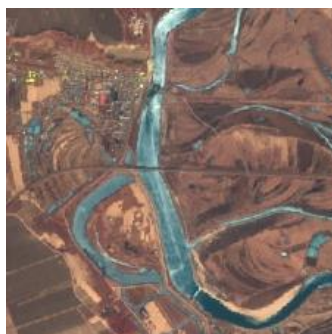
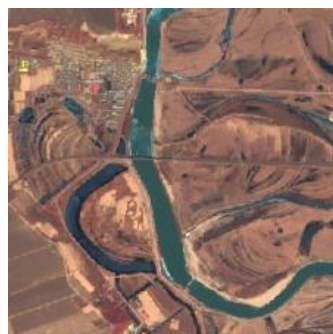
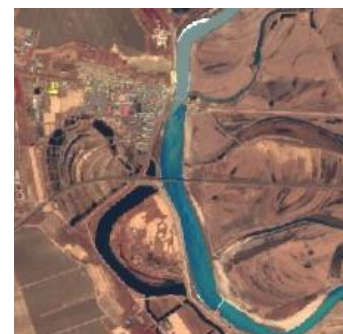
Figure 2: Image of Yijimi river near Lanxi old bridge before and after the accident

Image of Lanxi old bridge
on March 29, 2020

Image of Lanxi old bridge
on April 5, 2020

Image of Lanxi old bridge
on April 10, 2020

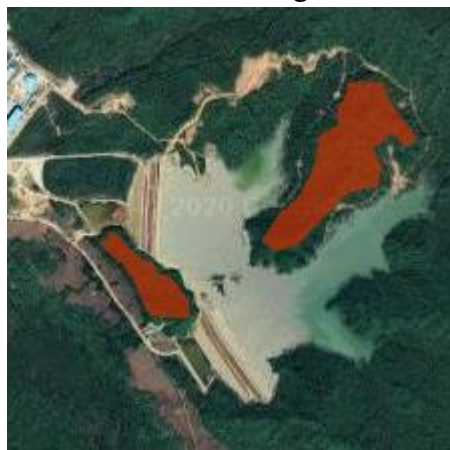
Figure 4: Vector of forest farm around tailings pond

There are several large forest farms around the tailings pond where the dam break accident occurred, and the surrounding forest farms are the first to be affected by the tailings pond leakage accident. In order to determine the impact of dam break accident on surrounding forest farms, based on Sentinel 2 images provided by GEE from 2020-03-28 to 2020-07-29, the NDVI changes of the two forest farms closest to the tailings pond are calculated and compared with the NDVI of the same period last year. The results are shown in Figure 5 and 6:

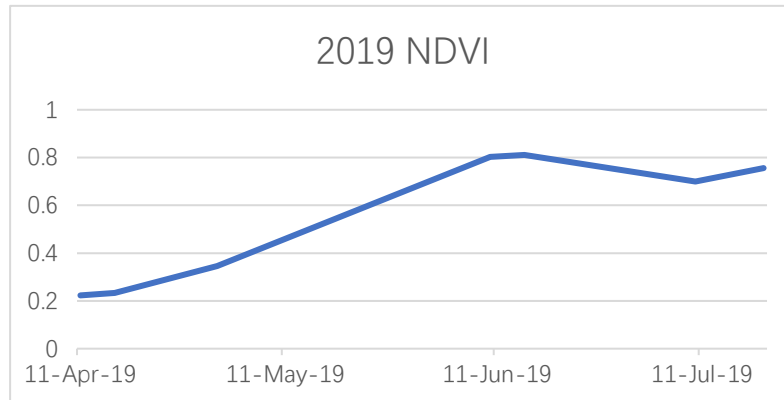
Figure 5: NDVI changes of forest farms around tailings pond in 2019

Comparing the average NDVI curves of forest farms around the tailings pond in 2019 and 2020, it can be seen that the NDVI curves of the two years have not changed significantly, which indicates that the accident has not had a significant impact on vegetation at present.

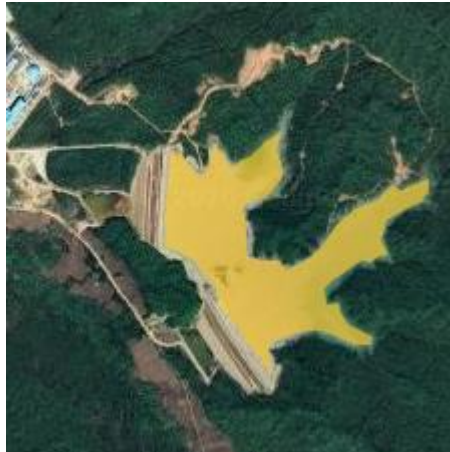
Figure 7: Vector of tailings sand

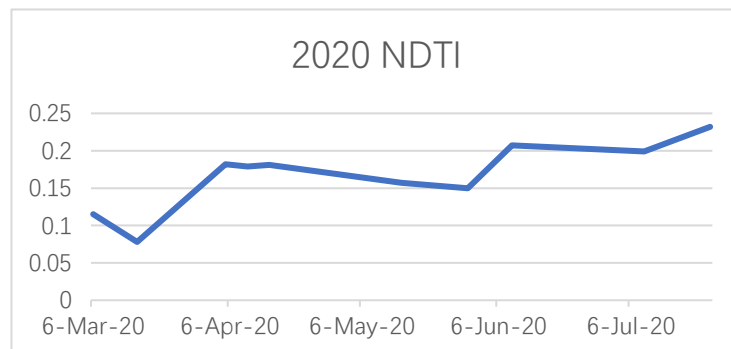
Figure 9: NDTI in the study area from March 1, 2020 to July 1, 2020

Comparing the NDTI curves of the same period of two years, it can be seen that the overall NDTI of the study area in 2020 is lower than that in 2019, which indicates that the water content of tailings decreased after the accident. The decrease in water content of tailings indicates that remedial measures such as pumping water have been taken after the accident, and the production of the mining area may not have resumed due to the responsibility for the personal and property safety of residents around and downstream of the mining area.

Import 2019-03-01 to 2019-07-29 in GEE respectively; From March 1, 2020 to July 29, 2020, Sentinel 2 images of the research area are taken as the research area, and the average NDTI of the research area is calculated. The results are shown in Figure 8 and Figure 9:
