COASTLINE CHANGE DETECTION USING REMOTE SENSING APPROACH IN BULELENG REGENCY, BALI PROVINCE

Amandangi Wahyuning Hastuti (1)(2), Masahiko Nagai (1)

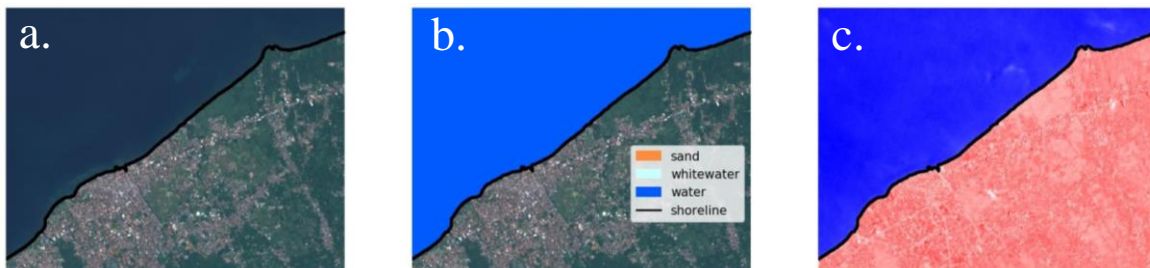
Figure 4. a) RGB image of certain study area; b) Output of image classification where each pixel has been labelled with one of three classes; c) Grayscale image of the MNDWI pixel values

Where SWIR1 and Green are the pixel intensity in the short-wave infrared band (1.55-1.65 μm) and green band (0.52-0.6 μm). The MNDWI value is computed for each pixel, resulting in a grayscale image with values ranging from -1 to 1.

There are two steps in this algorithm: (i) image classification (ii) sub-pixel resolution border segmentation by applying The Modified Normalized Difference Water Index (MNDWI).

The objective of image classification is to extract information from a set of homogeneous and natural regions into classes. This step is to find the pixels within every image that correspond to sand and water by supervised classification.

Modified Normalized Difference Water Index (MNDWI) is one of the best methods to discriminate water from land features with an accuracy rate of 99.85% (Xu, 2006). This method also widely applied to mapping the water bodies (Du *et al.*, 2016; Hasan *et al.*, 2019). MNDWI calculated as follows:

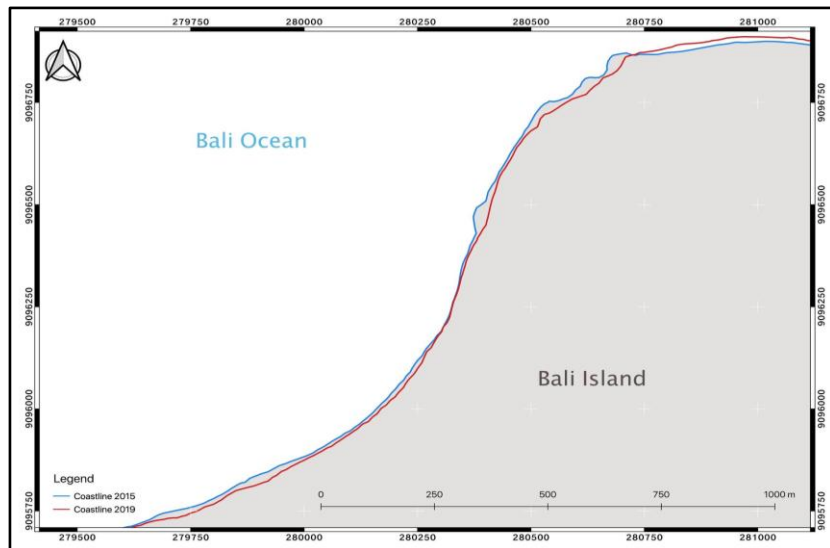
Coastline changes that occur at Buleleng Regency obtained by comparing coastline in 2015 and 2019 using the overlay method. This method is commonly used to detect longer-term coastline changes. The displaced coastline is then measured and the rate of change calculated.

Figure 5. The overlaying image from different years

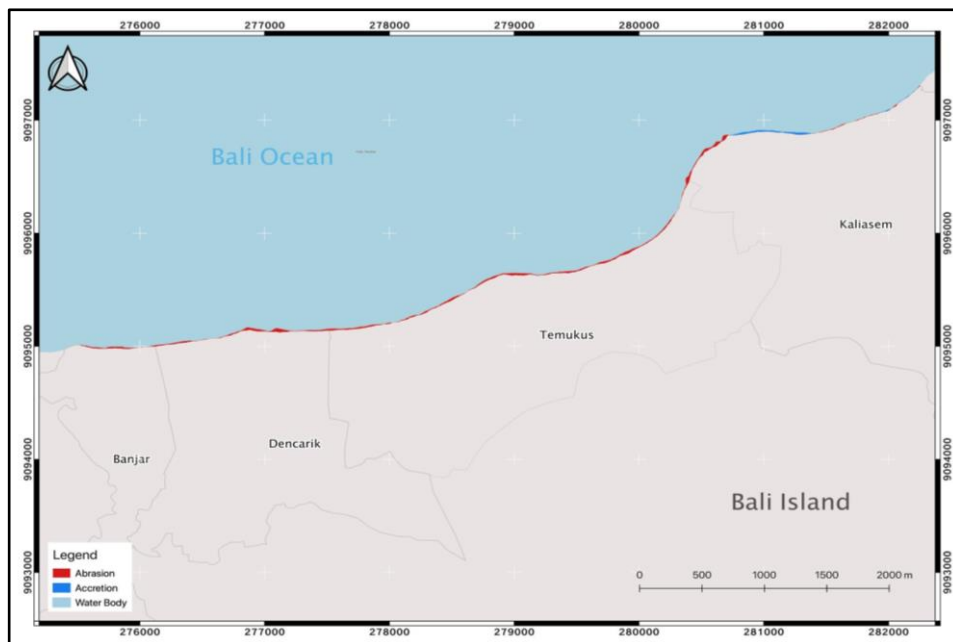
Figure 6. Coastline change at Banjar District

The coastal morphology of Buleleng Regency generally grouped into “mountainous cost”, that is coastal made by volcanic eruption and classified as sandy beach. Based on satellite image overlay can note that the whole study area experienced the coastline change mostly is abrasion (Figure 6, Figure 7, and Figure 8). In general, all along the coastline at the study area shows that for 4 years there has been a change in its coastline. Figure 6 showed that the most abrasion was observed along the Temukus Village with 32,578 m² and the accretion was confined to Kaliasem Village with 8,756 m². The details of area changes in Banjar District can be seen in Table 2. As with abrasion, accretion will occur. The reason for this accretion could be caused by the longshore current processes that allow the water to transport sediment.

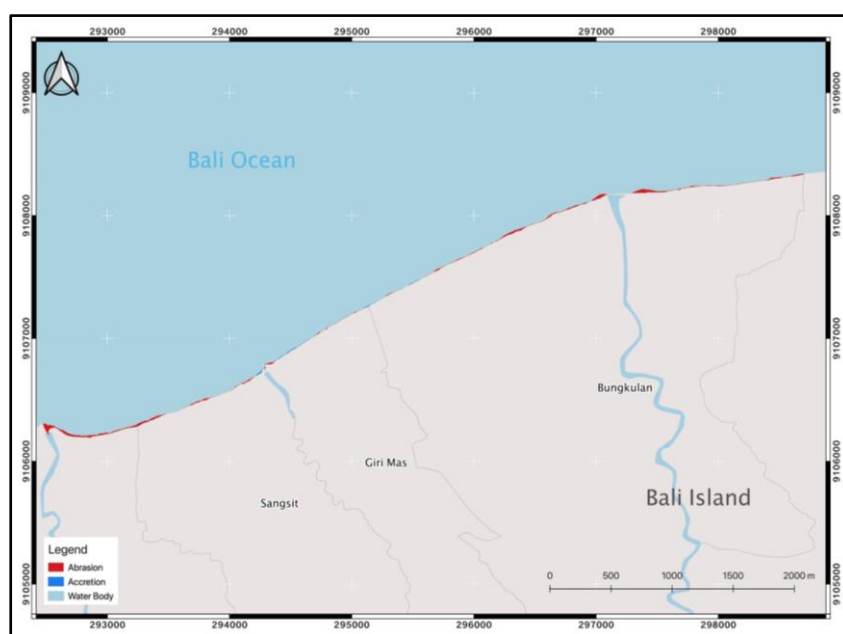
The coastline of 2019 at Sawan District was retreat as compared to 2015. Total sediment loss at this district is 36,980 m² with the most abrasion located at Bungkulan village with 18,573 m² changes. At Sawan District, there are three rivers which cut away the coastline and enter the sea (Figure 8). The accretion was occurring in the river between Sangsit and Giri Mas village. This happens due to the sediment deposition that occurs caused by reduction of current velocity when reaching a point where the coastline disappears, either because of a river and unable to carry the sediment back to the ocean. On the other hand, the river mouth is also a great vulnerable area to coastline changes. This area is very dynamic considering the changes occur as a result of sedimentation processes and may take seasonally.

Figure 8. Coastline change at Sawan District

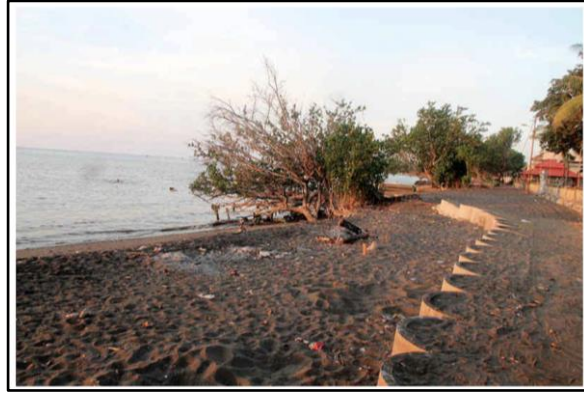
Figure 9. The revetment at Buleleng beach to protecting the coastline from abrasion (Source: Balipost)

Many prevention attempts have been conducted by the local government and local community as the effort to protect the coastal area has been made by building the revetment, seawall, groin, artificial headland and detached breakwater. But the existing coastal protection structures are not optimal in efforts to protect the coast.
