# Long Term Topographic Changes in the Haeundae Region

**Abstract :** The coastal zone has got settled as an important space topologically and geographically. As such, it provides value according to the uses to which is applied. However, by the excessive development and the shortage of the management, the coastal zone including coastline, beach, bank, tideland and river mouth has been destroyed. Therefore, the ability to detect coastal topographical change has emerged as an important issue. Generally, the monitoring of coastal topographical change is accomplished through aerial photography, direct survey, or the use of topographical mapping. Such data collection makes possible a systematic and scientific analysis. Therefore above all things, accurate data of the costal zone should be collected for the analysis. In this study, we collected data through the sounding and the beach survey and analyzed the topographical change in Haeundae region during long term. As a result, we could acquire not only the coastal depth data but also the data from the GPS surveys. And we examined the feasibility of manufacturing variable thematic maps and surveys and examined these data as the available

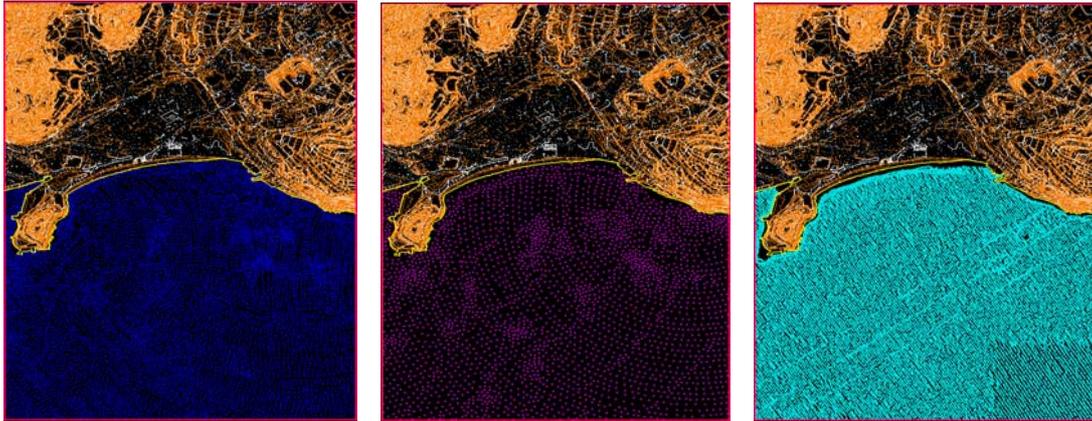
As Fig. 1, we overlaid results obtained from sounding with digital maps issued by National Geographic Information Institute of Korea in 2000 and generated original survey drawings of Haeundae. We extracted marine digital elevation model(DEM)s from original survey drawings using Intergraph MTA&InRoads software, as raster data consisted of grids are more useful to compute the depth of the water, the area and the volume than vector data.

Fig. 1 Original survey drawings of Haeundae beach (1980, 1994, 2005)

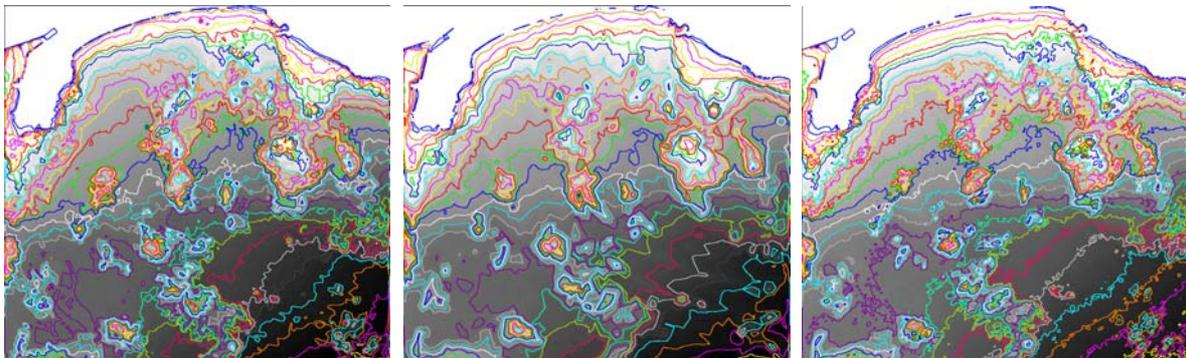
We derived each isobaths from marine DEMs and overlaid these with marine DEMs. As a result of the visual analysis, the erosion generally has happened up to 300m away from the beach including Dongback island and Mipo. And reef zones are clearly evident on several places.

Fig. 2 Isobaths of Haeundae beach (1980, 1994, 2005)

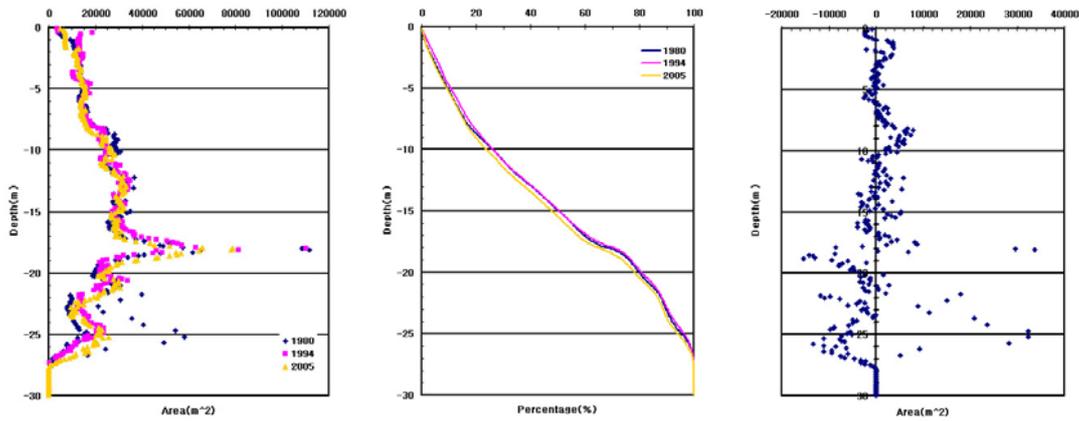
The area by the sounding indicated that the increase was generated at 0~1m, decrease at 1~5m, increase at 5~6m, decrease at 6~10m, increase at 10~11m, decrease at 11~13m and decrease above 13m during 25 years. The initial sounding section to exhibit the decrease is 1m~5m and the maximum sounding showing the decrease is 1.5m in which tourists mainly bathe. If the area of this sounding decreases continuously, Haeundae will loss its value as sightseeing resort.

**Fig. 3 Changes in the area and the volume by sounding**

1. As a result of statistical analysis of marine DEMs, total volume of the marine topography in the Haeundae region has gained in quantity as 2207884 for 25 years. But the mean depth of water and total area have eroded in quantity as 0.39m, 11028 . The area by the sounding indicated that increase was generated at 0~1m, decrease at `1~5m,

increase at 5~6m, decrease at 6~10m, increase at 10~11m, decrease at 11~13m and decrease above 13m. The maximum sounding showing the decrease is 1.5m in which tourists mainly bathe. If the area of this sounding decreases continuously, Haeundae will lose its value as a sightseeing resort.

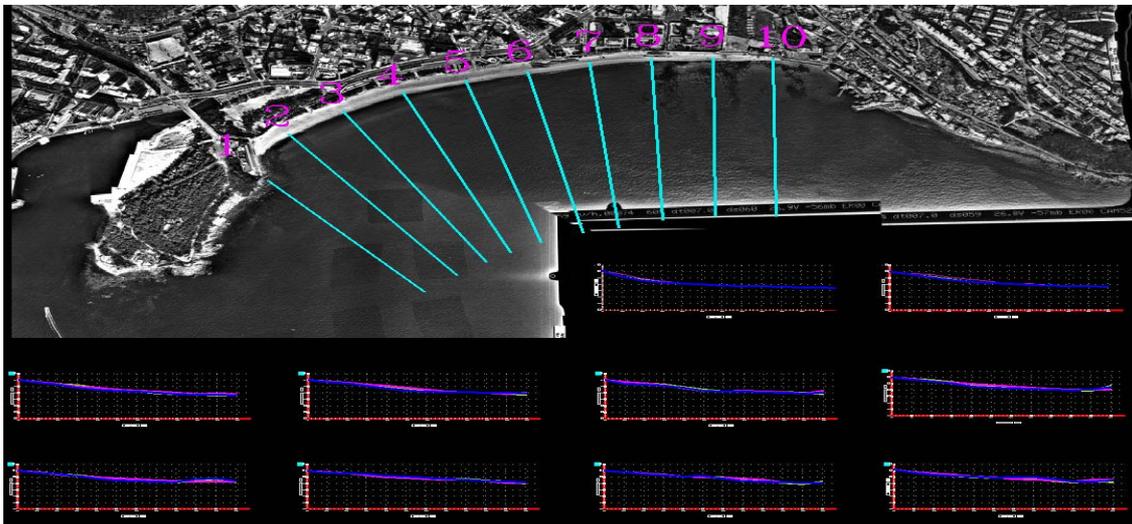
**Fig. 4 Cross section of the sounding survey (Blue : 1980, Green : 1990, Pink : 2000)**

To analyze the equal interval changes in topography for 25 years, we constructed cross sections from marine DEMs. We derived cross sections at 160m intervals from Chosun Beach Hotel, overlaying data from 1980, 1994 and 2005. We then computed the depth of erosion and accumulation at intervals. Results are Fig. 4 and Table 2. As indicated by Fig. 4, there were generally accumulation in 1994 and erosion in 2005. In case of the center to supply sand

intensively and the east (Mipo), erosion appears subtly and accumulation appears in some places. However, in case of west (Chosun Beach Hotel), erosion appears obviously.

2. As a result of analyzing the marine topographic cross section, there were generally accumulations in 1994 and erosion in 2005. In case of the center beach to supply sand intensively and the east (Mipo) beach, erosion appears subtly and accumulation appears in some places. However, it is necessary to monitor this region for the management of the beach during the long term, as erosion appears obviously in the west (Chosun Beach Hotel) beach.

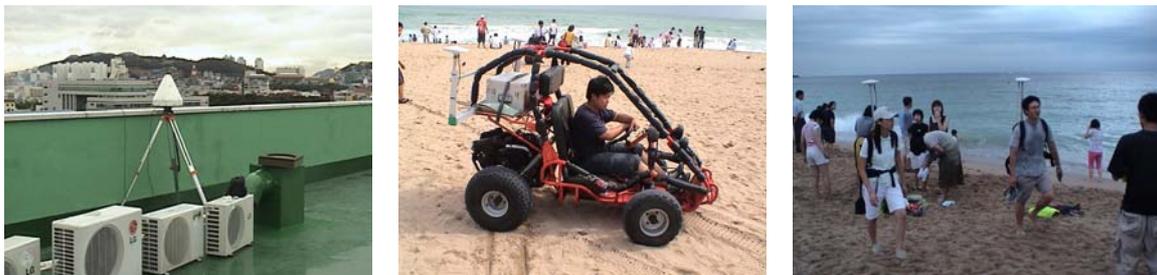
As construction stage of data to investigate beach topographic change, we selected surveying date based on time of high tide and made a survey using GPS from 16:00 20 August 2005 to 4:00 21 August. We selected Pukyong National University, Korea as the temporary datum point and set up the receiver. In the post process kinematic GPS method, we surveyed the coastline and the beach of Haeundae at 1 meter intervals parallel to the coastline.

Fig. 5 Field Experiment

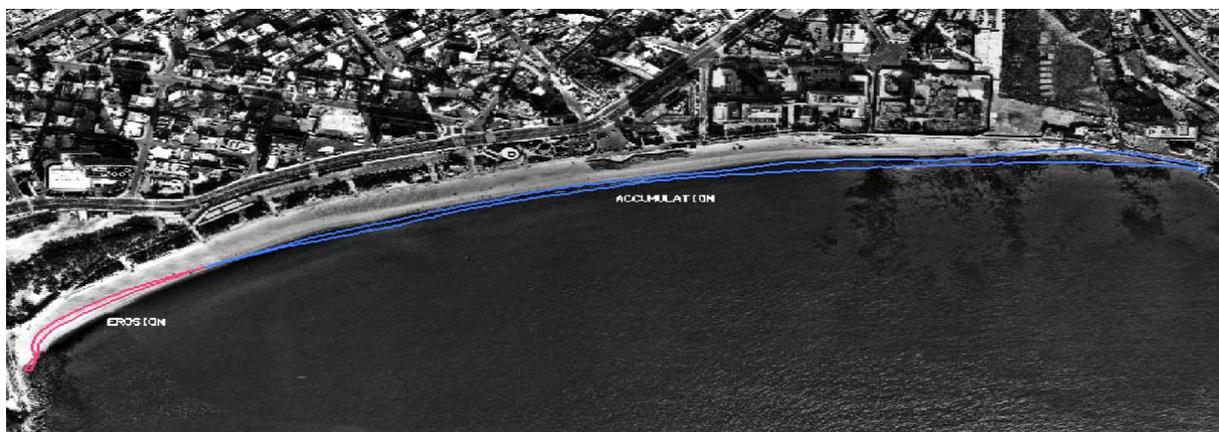
Fig. 6 Change of coastline for 5 years

As a result of visual analysis of beach DEMs, the coastline has advanced on the left side and receded on the right, centering around Glory Condo.

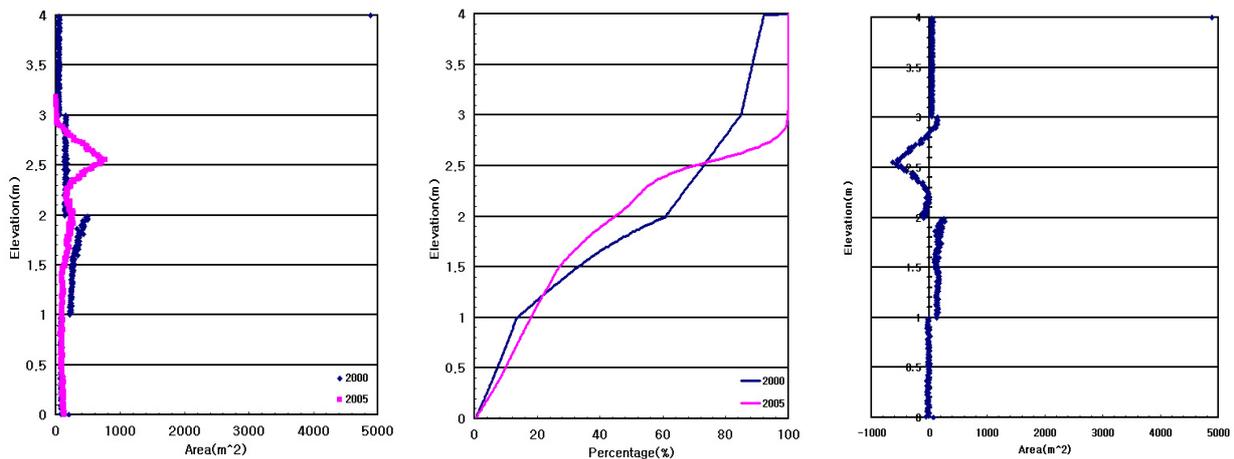
Much sand has been flowed into Haeundae beach through supplying sand from the west coast. But beach erosion has been occurred. As multistory buildings stood into the coastal zone by the excessive development and river to supply sand into the beach disappeared, it is estimated that ocean current was changed and condition that sand goes in and out the beach was destroyed. Therefore beach erosion has been occurred continuously. The area and the volume at 2~3m elevation have increased and sand has been accumulated. But area and volume at 1~2m elevation has decreased and sand has been lost.

**Fig. 7 Changes in the area and the volume by sounding**

3. As a result of statistical analysis of beach DEMs, total volume, area and the mean elevation of the beach has eroded in quantity as 17181 m<sup>3</sup>, 0.08m and 6357 m<sup>3</sup> for 5 years. The area and the volume at 2~3m elevation increased and sand was accumulated. But, at 1~2m elevation, they decreased and much sand was lost. As multistory buildings stood into the coastal zone by the excessive development and river to supply sand into the beach disappeared, it is estimated that ocean current changed and condition that sand goes in and out the beach was destroyed. Therefore beach erosion has been occurred continuously.

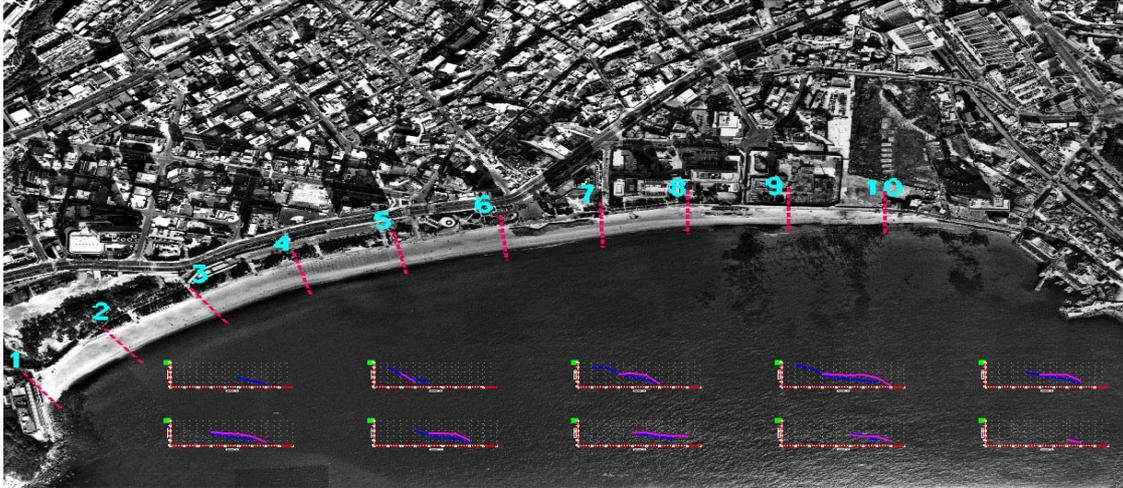
To analyze the equal interval changes in topography for 5 years, we constructed cross sections from beach DEMs. We derived cross sections at 100m intervals from Chosun Beach Hotel, overlaying the data from 2000 and 2005. We then computed the depth of erosion and accumulation at intervals. Results are presented in Table 4 and Fig. 8.

As the point month of surveying was August when two months had been passed after supplying sand, accumulation has generally occurred. Particularly, accumulation has clearly occurred in center of beach. Its causes are estimated that EBR Systems Corporation established minute nets composed of PVC at 30m intervals up to 2m depth of water in front of center of beach. In other words, by the installation of minute nets, the velocity of waves has been slower than old times and sand to be washed by waves has piled up. Therefore degree of erosion in the center beach is weaker than one in other regions.

But erosion has been occurred clearly in west beach (Chosun Beach Hotel). At that time to survey, there is hardly sand in front of Chosun Beach Hotel. Its causes are as follows.

Fig. 8 Cross section of the sounding survey (Blue : 2000, Pink : 2005)

First, sand to be distributed over the beach by velocity of waves and winds has been accumulated intensively in the center beach by the installation of minute nets and couldn't have reached in the west beach. Therefore erosion has been occurred clearly in west of beach.

4. We analyzed the cross section of beach. As the point month of surveying was August when two months had been passed after supplying sand, accumulation has generally occurred. By installation of minute nets in the center beach, sand to be washed by waves has piled up. Therefore accumulation has clearly occurred in the center beach. However erosion has been occurred clearly in the west beach as sand to be moved in the west beach by waves and winds has been accumulated intensively in the center beach by installation of minute nets. It is estimated that season affects erosion in the west beach. As a result of analyzing aerial photos, the area of the west beach (Chosun Beach Hotel) in the summer is narrower than one in winter as 1396 m<sup>2</sup> and the area of the east beach (Mipo) in the summer is wider than one in winter as 581 m<sup>2</sup>.

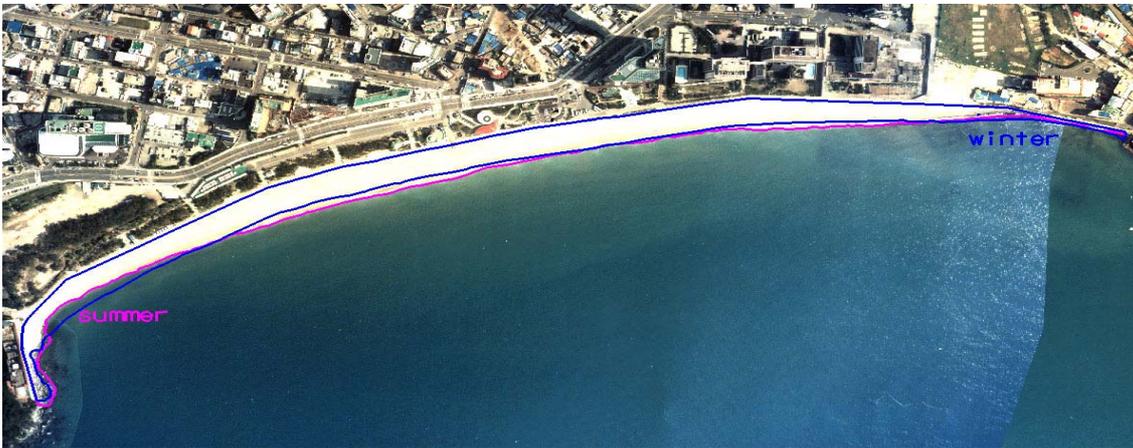
Second, the area of Haeundae beach changes according to the season. We analyzed the area of the beach from aerial photos to be taken a photograph in the summer (May) and the winter (November) and we could know the area of beach changes according to the season. During the summer, the beach area in front of Chosun Beach Hotel is narrower and the beach area in front of Mipo is wider. But, during the winter, the beach area in front of Chosun Beach Hotel is wider and the beach area in front of Mipo is narrower.

Fig. 9 Seasonal change of Haeundae beach area
