# APPLICATION OF GIS & REMOTE SENSING IN TSUNAMI MAPPING IN CAR NICOBAR ISLANDS

\*Dr. Arun Kumar, Dr. R. K. Chingkhel and Th. Dolendro  
Department of Earth Sciences, Manipur University, Manipur, India  
Phone: +91 385 2435173, Fax: +91 385 2435083 \*email:arun117@hotmail.com

**ABSTRACT** The Great Indonesian Earthquake (M9.3) triggered at 6.30 IST and felt and damaged partially large number of buildings of the island. The first tsunami wave hit the island around 6.45 am due near tsunami field. The second Tsunami wave hit the island around 7.15 am and resulted in a great damage to the peripheral part of the island. The present studies deals with the assessment of the damages caused by the Great Tsunami. The GIS and multivariate Remote Sensing (high resolution) data are used to delineate the various landuse patterns that are affected by the Tsunami. The assessment indicates the damages of the existing beaches, coral life, forest lands, urban areas, mangroves, coconut plantation, waterlogged areas etc. The extensive field surveys have been conducted in the island and followed by digital image processing of the satellite data. The generation of the damages caused by the tsunami has

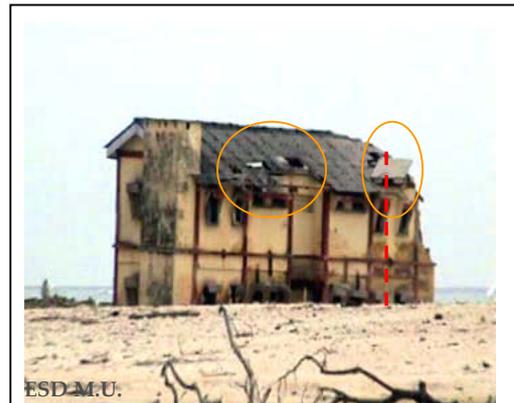
Fig 3 Damaged roof of the building indicates tsunami height

The major portion of the island's coastline corridor are found be badly affected by the Great Tsunami of 26<sup>th</sup> December 2004. The total distance of coastline corridor being affected and damaged is about 37.52 km. And the majority of the damages were observed along the coast of 'Aukchung-Kimus-Kakana' and 'Malacca-Tapoiming-Lapathy-Mus' villages. It was observed that these areas were struck by the highest waves, some more than 15 m high. Waves that hit the north-facing coastline of T-top and Passa were lower, about 8-10 m high, but the low-lying nature of the area allowed those waves to penetrate far inland. It is observed during the survey that many two storied buildings are inundated by tsunami waves (Fig 3) and trees have the debris carried by tsunami water (Fig 4) indicating the height of the tsunami.

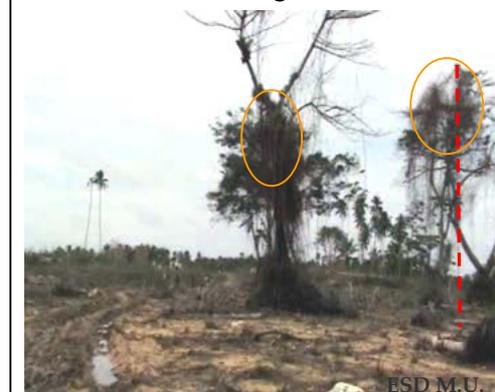
Fig 4 Debris on trees indicate tsunami height
