Damage Detection Based on Object-based Segmentation and Classification from High-resolution Satellite Images for the 2003 Boumerdes, Algeria Earthquake

Keywords: 2003 Algeria Earthquake, Damage detection, Object-based classification, High-resolution satellite.

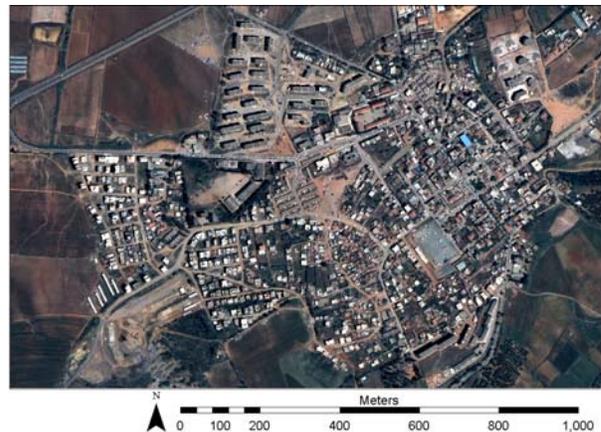
Figure 2. Pan-sharpened natural color QuickBird image of Zemmouri City acquired on 23 May 2003.

Then, pan-sharpened images were produced through combining panchromatic images of 0.6 m resolution and multi-spectral images of 2.4 m resolution, as shown in Fig. 2. By this image enhancement, buildings, cars and debris can clearly be identified. A pre-event image and a post-event pan-sharpened image were produced and they were used in visual damage inspection. As well as that, the post-event image was used in automated damage detection.

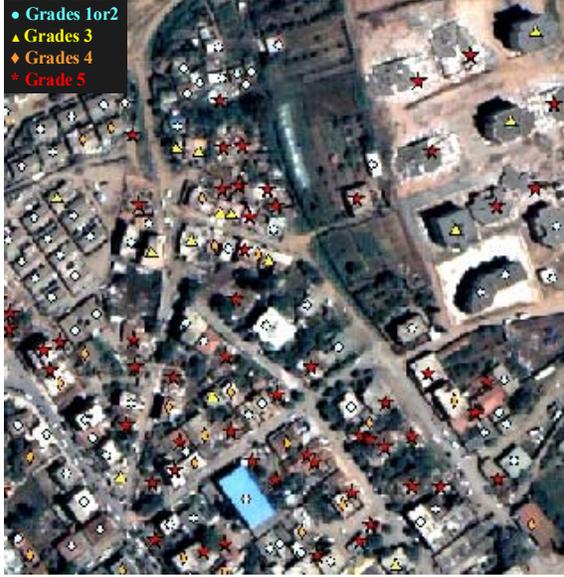
Figure 5. Result of visual building damage detection.

The visual inspection of building damage in Zemmouri City was conducted based on the classification in the European Macroseismic Scale [10] shown in Table. 1. Using both the pre- and post-event images, buildings surrounded by debris (Grade 3), partially collapsed buildings (Grade 4) and totally collapsed buildings (Grade 5) were identified. For the purpose to obtain more confidence in the result of the visual detection, five persons who are researchers and graduate students in the fields of structural engineering conducted visual inspection and majority damage levels were determined. The detection result of the majority grade is shown in Fig. 5. As is mentioned above, this result would have an acceptable accuracy and be really useful in the damage analysis of disasters although, ideally, it is necessary to evaluate the accuracy of the detection result based on ground truth data.

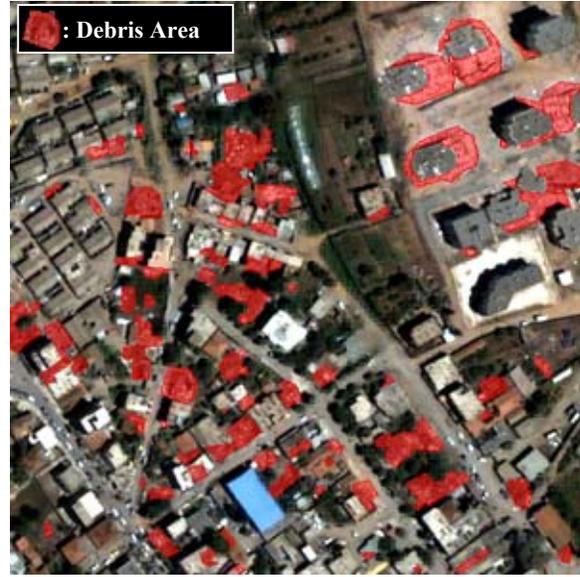
Figure 6. Debris visually detected.

Next, as is shown in Fig. 6, debris due to the destruction of buildings was identified and extracted focusing on buildings classified as damaged in the visual inspection. Out of 262,114 pixels in the 512x512 image, 23,493 pixels were judged as areas of debris. These could be considered to be reliable truth data to evaluate the accuracies of automated damage detection techniques. It should also be mentioned that it took a half to an hour to detect debris areas this time.

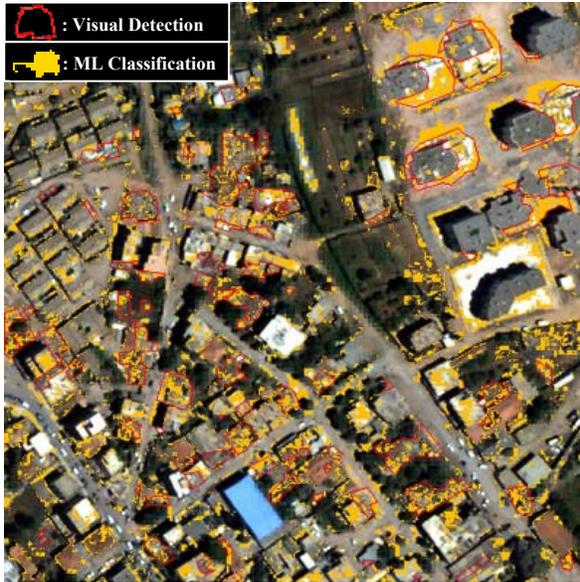
Figure 7. Debris detection by the pixel-based approach

Before performing ML classification, classes were set as follows: gray-roof building, white-roof building, red-roof building, blue-roof building, car, shadow, road, soil, vegetation, and debris. Then, samples for all classes were selected from the post-event image. Finally, the image was classified into the classes mentioned above and only the class of debris was extracted. Fig. 7 shows debris areas classified by the pixel-based approach and those visually detected.

As a result, it seems that debris that has been detected is scattered about in a whole image. Additionally, this result indicates that the area classified as debris out of that is extracted in the visual detection is not so large and that some errors are seen on the roofs of buildings. The accuracy is discussed and compared with the result of object-based classification in the next section later.

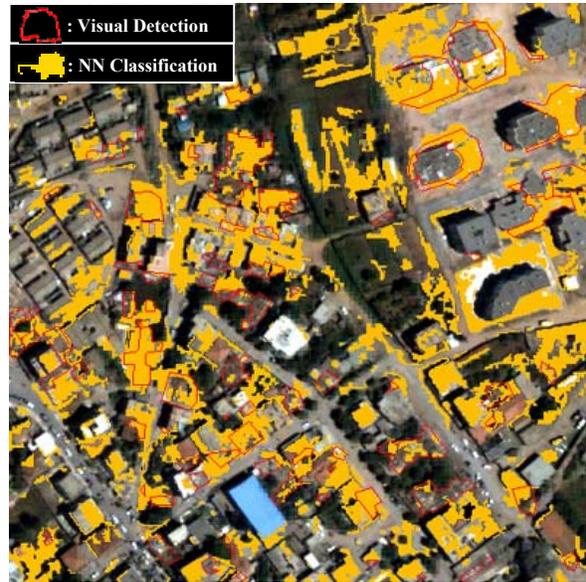
Figure 8. Debris detection by the object-based approach

Second, samples of classes that consisted of gray-roof, white-roof, red-roof, and blue-roof buildings, car, shadow, road, soil, vegetation, and debris were selected from the same areas as those used in the pixel-based classification. Using the sample objects' mean values of blue, green, red, and near-infrared band values, and brightness data as indices, the nearest neighbour classification, which is one of the supervised classification techniques, was conducted. After that, the objects classified as the debris class were extracted and shown in Fig.8.

Considering the result of the object-based classification, larger areas visually detected as debris have been identified as debris in the object-based damage detection than the pixel-based detection. However, it seems that more errors exist in the areas of white buildings and vegetation. Since merging pixels has removed the variance of spectral data among neighbouring pixels, it can be seen that dotted errors and voids have disappeared. In other words, this approach could realise that an object that spreads to some extent is certainly identified as one homogenous area despite the minute fluctuations of pixel data within the object.
