Application of Multi Temporal Satellite Data for the study of Water Resource problems in Udaipur Basin, South Rajasthan, India

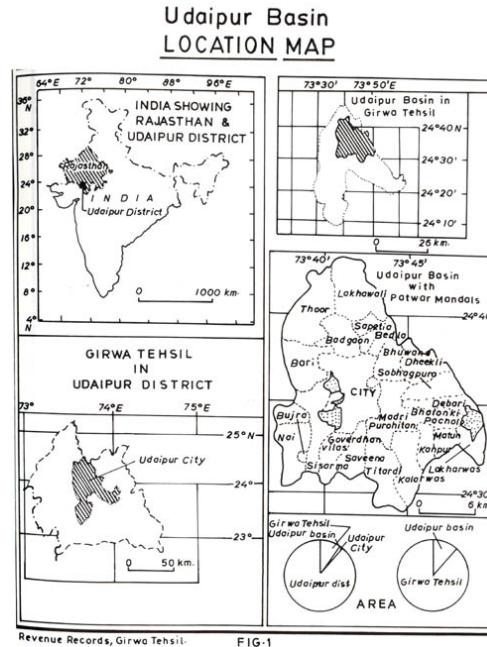
FIG-1

The study area Udaipur Basin lies between $73^{\circ}36'51''$ East to $73^{\circ}49'46''$ E longitude and $24^{\circ}28'49''$ to $24^{\circ}42'56''$ North latitude (Fig-1). It is a saucer shaped basin 22 kms wide from East to West and 24 kms long from North to South. It is wider in the South and tapers northwards. Its average height is 577 meters above the mean sea level. The tropic of cancer lies 122 kms to the South of the study area. Udaipur City popularly known, as the city of Lakes or Venice of the East is a picturesque city located to the south of the North-Western state of Rajasthan in India. Founded by Maharana Udai Singh of Mewar in 1559 A.D. Udaipur is one of the most majestic and historical city with rich cultural heritage and diversity.

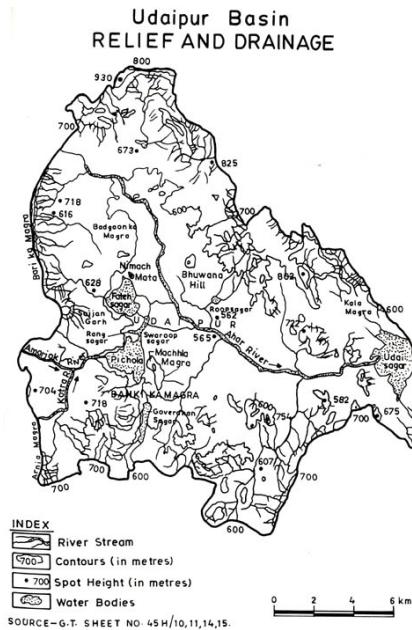
FIG-2

A brief insight into the physiography, geology, drainage and climatic conditions of the study area would not be out of place for an objective analysis of the problem. Structurally Udaipur basin is a saucer shaped basin in form of a deep valley surrounded by the Aravalli hill ranges which girdle it from all sides. Locally it is called Girwa meaning a range of hills (Fig-2)

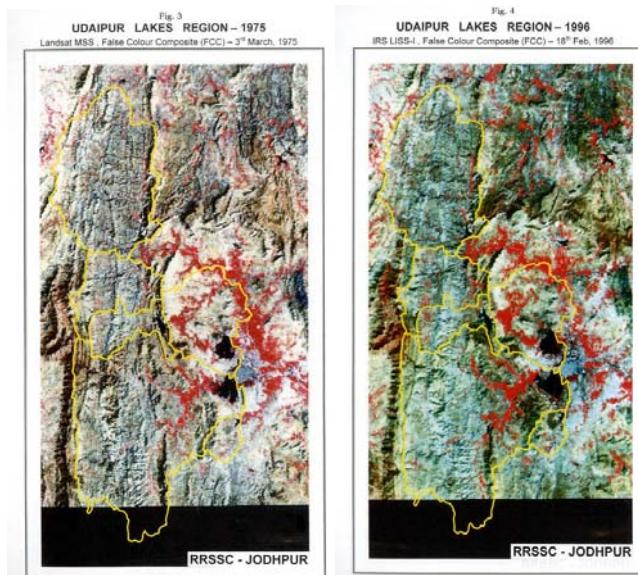
Another reason for the prolonged drought is the depletion of the environment of Udaipur basin. Forests have been recklessly destroyed from the catchment area of the lakes. In the past 45 years between 1960-2004 almost 60% forest cover has been removed from the surrounding Aravalli hill ranges which now bear a deserted look. This is clearly visible from the visual interpretation of the satellite image of 1975, 1996 and 2004 (Figs. 3, 4 & 5). This has resulted in the decline of the rate of evapotranspiration and increased soil erosion.

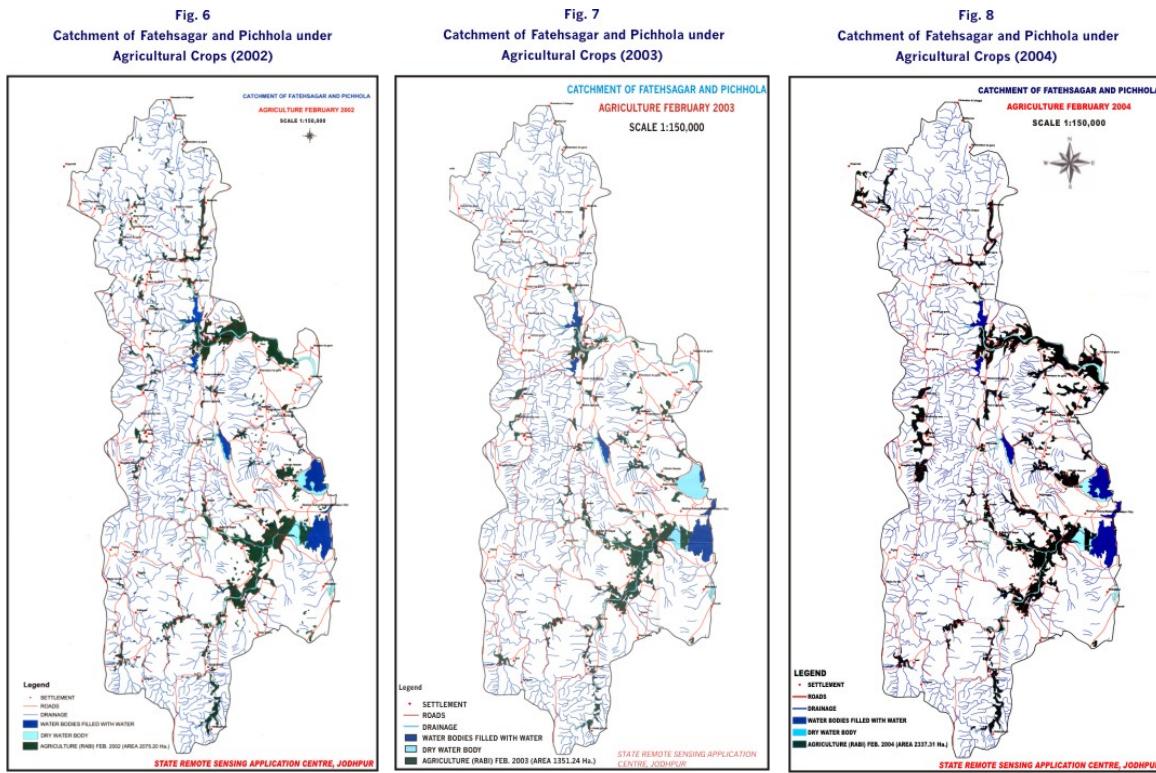
An important feature of the cultivation has been the rapid expansion of cultivated area in the lake bed region as revealed by the satellite imageries of the cropped area in the catchment of Fatehsagar and Pichhola, the two principal lakes of Udaipur city in the year 2002, 2003 and 2004 (Figs. 6,7 & 8). The dry beds of the lakes and rivers have been used for intense cultivation that exhibits an excellent example of dry land farming rapid. This expansion of seasonal farming in and around the lake bed regions has however also caused adverse impact on the underground water and has also disturbed the surface symmetry.
