URBAN STRUCTURAL DAMAGE ASSESSMENT WITH OBLIQUE UAV IMAGERY, OBJECT-BASED IMAGE ANALYSIS AND SEMANTIC REASONING

Norman Kerle, Jorge Fernandez Galarreta, and Markus Gerke
Faculty of Geo-Information Science and Earth Observation (ITC), University of Twente, P.O. Box 217
7500 AE Enschede, The Netherlands,
Email: n.kerle@utwente.nl, m.gerke@utwente.nl, jorfgal@gmail.com

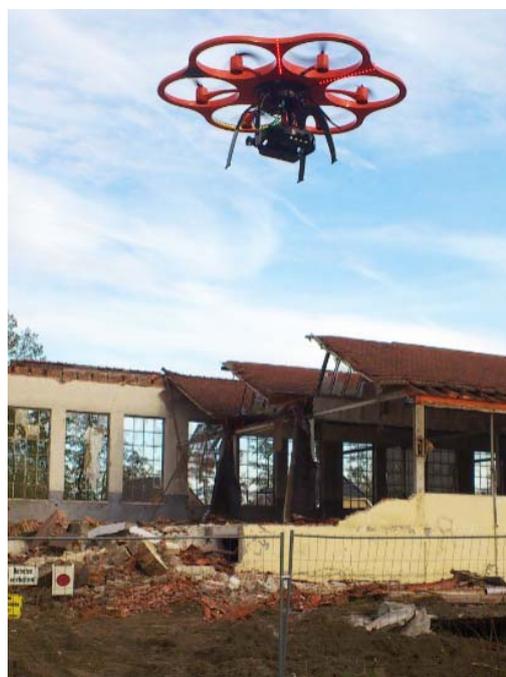
Figure 1: Aibot X6 use in Gronau (Germany), leading to the data shown in Figures 3A/D.

The imagery used in this study was collected both with an Aibot X6 V.1 UAV (Fig. 1), and with a camera attached to a 7 m pole. The latter was necessary because the highly variable legal framework for civilian UAV deployment does not permit such devices to be used in a number of countries, and the pole allows oblique UAV data to be well simulated. On the UAV we used a Canon 600 D with a 70 mm fixed zoom length, resulting in a GSD of approximately 7 mm at a 70m flying height. On the pole we used a Canon PowerShot S100. Deployed at some 15 m from a target building the image GSD was approximately 1 cm. Images were acquired in Gronau (Germany), Enschede (The Netherlands) and at several locations near the city of Bologna (Italy), where a magnitude 5.8 earthquake in 2012 caused extensive structural damage.

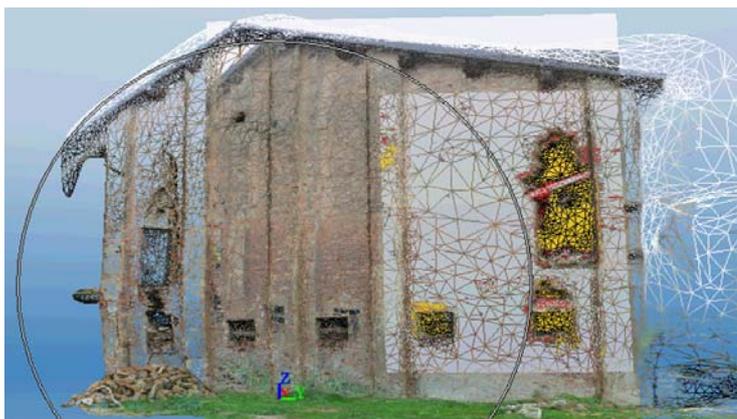
Figure 5: Wire-mesh model of the building shown in Figure 3C, with the colored point cloud, as well as detected damage (windows/holes) overlaid. The point cloud, but also individual damage type layers can be selectively activated for enhanced interpretation by an analyst.

The extracted damage information was provided to 6 experienced damage analysts (for example superimposed on a wire-mesh as shown in Figure 5), to understand the value of such auxiliary information. Contrary to expectation, analysts saw little value in the highlighted structural damage features as shown in Figure 4, as those largely correspond to the features an experienced analyst can readily detect based on the spectral image information. However, the additionally extracted information based on the geometric derivatives (Figures 3 D-E), which cannot easily be detected in image data, were considered to be very useful.
