Project for Creating Digital Elevation Model Enabling Disaster Resilience in Sri Lanka

KEY WORDS: LiDAR, DEM, Disaster risk reduction, Flood, Landslide

ABSTRACT: The Japan International Cooperation Agency (JICA) LiDAR project aimed to help the disaster risk reduction in the Democratic Socialist Republic of Sri Lanka (Sri Lanka). The Project provides the Digital Elevation Model (DEM) which becomes the source of creating topographic data in disaster prone areas in the Colombo, Gampaha, Nuwara Eliya, Kegalle, parts of Kandy, Budula, Kalutara districts and surrounding areas. The Project started in January 2015 and completed in December 2016. There are two areas depending on the density of LiDAR measurement points. The 1 x 1 meter mesh area has 2,400 km², and the 2 x 2 meter mesh area has 5,400 km². The 1 x 1 meter mesh areas and the low land areas are accurate of ± 30 cm, and the 2 x 2 meter mesh areas have ± 50 cm - 100 cm. Some part of the Nuwara Eliya was excluded from the LiDAR survey because of weak GPS signal reception. The data with high vertical accuracy are available for updating topographic maps and preparing disaster management plans for the districts and communities. The

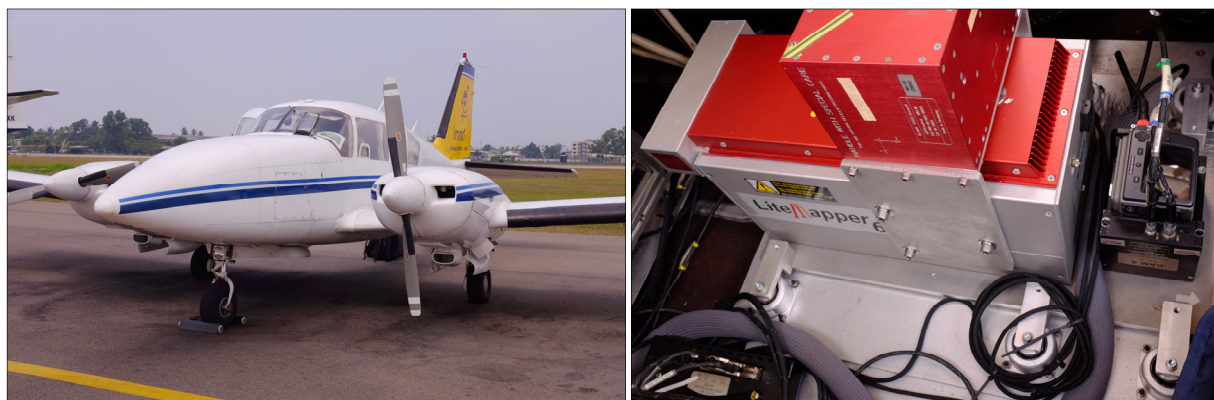
The aircraft and the equipment of the LiDAR survey are summarized in the following table and figure.

Figure 3-1 Aircraft and Laser Scanner

Table 3-1 Aircraft Parameters

Item	Parameter	Unit
Type	Piper PA23 Aztec	-
Registration	PH-KED	-
Wingspan	11	m
Length	9.51	m
Power	2 motors 250	HP
Speed	90 to 150	kts
Ceiling	4,200	m
Range	850	nm

Table 3-2 Sensors

Item	Manufacturer	Type
Laser Scanner	IGI	LiteMapper 6800i
Camera	IGI	DigiCam H60

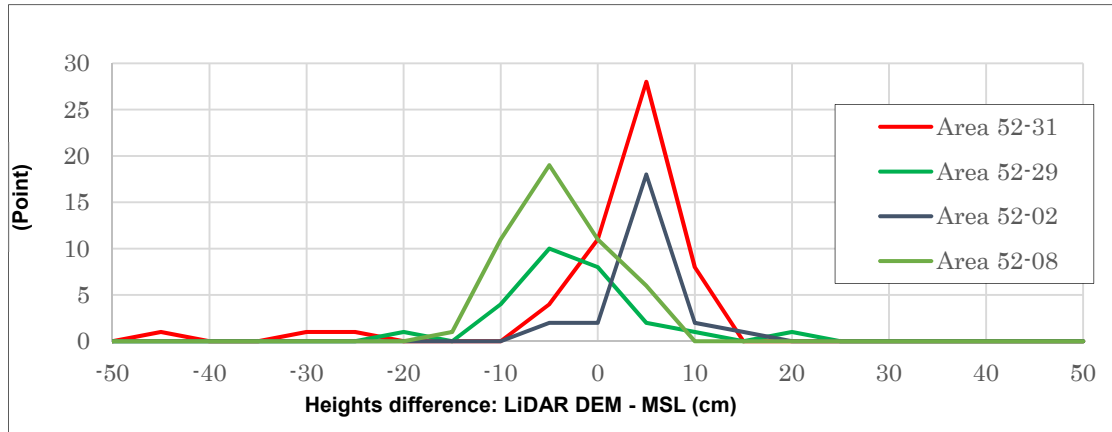
The Project Team has submitted the DEM data of four areas in the 1 m x 1 m mesh area on March 21, 2016. SDSL examined the data as it compared with the leveling data at corresponding locations. SDSL reported that the DEM data satisfied the precision stated in the Specifications as submitting a verification report.

Figure 3-4 Results of Verification of the DEM Data Precision

Table 3-4 Results of Verification of the DEM Data Precision

DEM Data	Validation Point	Heights RMS error	Specifications
Area 52-31	54 points	0.09 m	0.30 m or less
Area 52-29	27 points	0.08 m	
Area 52-02	25 points	0.06 m	
Area 52-08	48 points	0.06 m
