# COASTAL PROCESSES AND CAUSES OF SHORELINE EROSION AND ACCRETION OF THE BATHTHALANGUNDUWA ISLAND IN SRI LANKA

**ABSTRACT:** Baththalangunduwa is an elongated sandy island. It is located in the Portugal Bay extending about 16 km long from north to south, and maximum width is about 680m east to west. Coastal processes mainly erosion, transportation and deposition of the Baththalangunduwa island has been calculated from the period from 1985 to 2017. After analyzing data spatially, erosion can be seen especially in the western flank of the island. The area is faced with waves, swells, storm winds and tides of the Palk Strait during the southwest monsoon period and vice versa accretion can be seen especially in the northern and eastern flanks and along the southern corner during the northeast monsoon period. The waves, wind pattern and tide of the Portugal Bay are responsible for the transportation and deposition in the area. Due to these processes, along the eastern and southern flanks of the island, there form micro landforms such as sandy lobes and hooks, mud flats, sea grass beds, mangrove patches, incomplete small bays and lagoon features. Most of these features are temporal, and

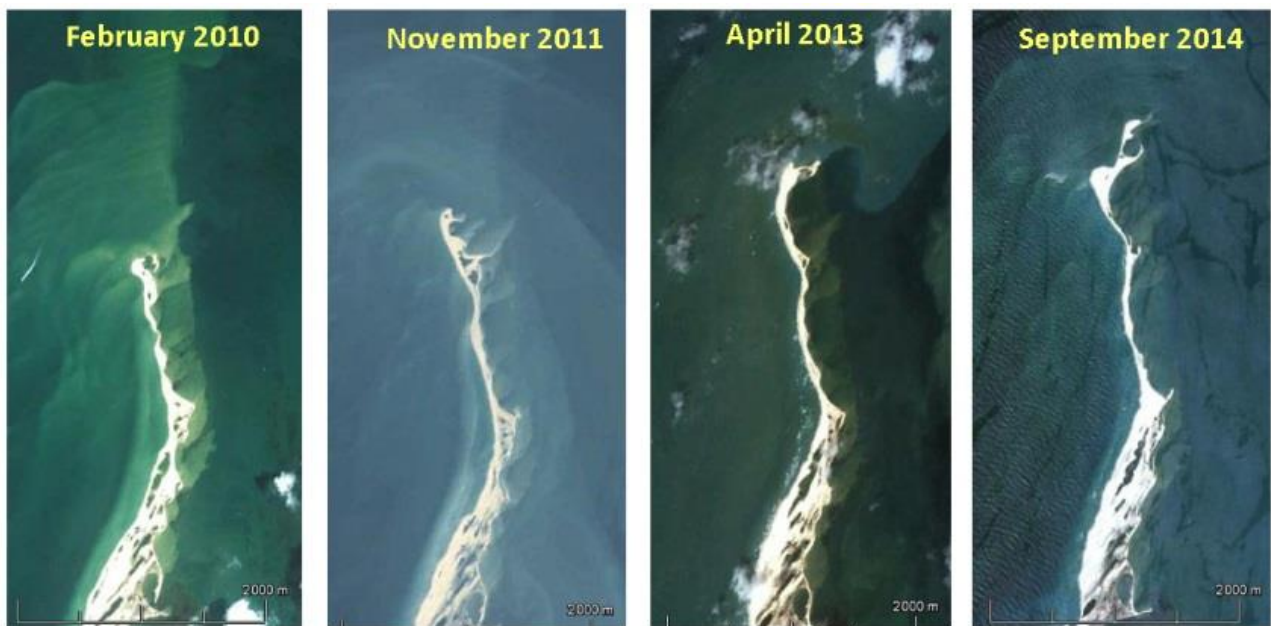
**Figure 4.** Development of Northern Tip of the Baththalangunduwa Island (Source: Google Earth).

mentioned, as an example the severe coastal erosion, which occurred during the southwest monsoon storms in 2016 year (Photographs G-L). Google images also reveal that the extending the island northwards and developing eastwards the island (Figures 4 & 5).

The depicted photographs clearly show this destructive activity. By this mean, fishing huts and semi permanent building were damaged and displace the hundreds of inhabitants. Likewise, we found that some changes have occurred northern part of the island (Figure 4).

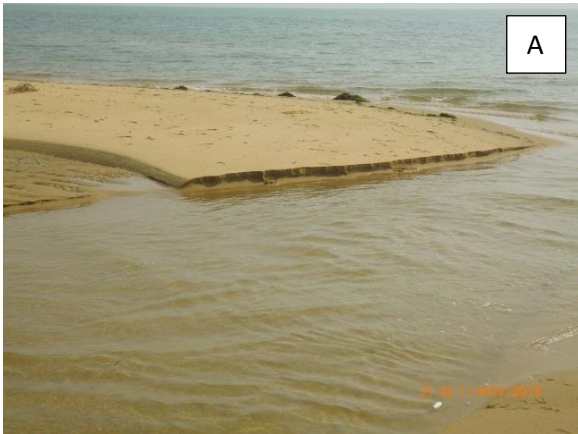
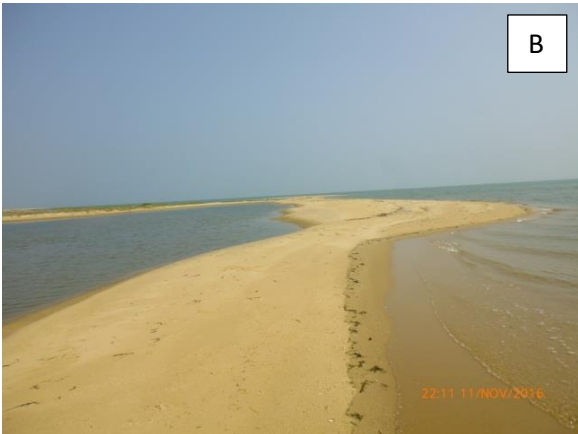
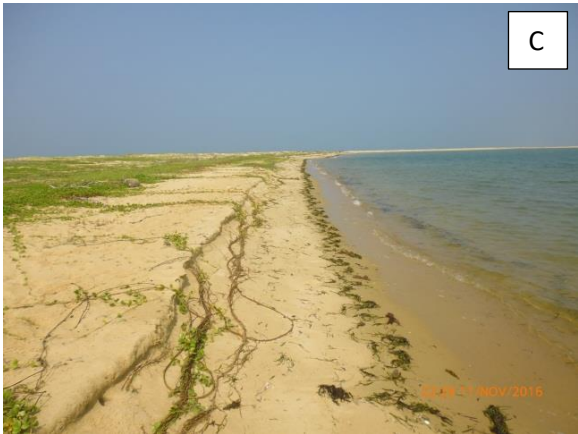
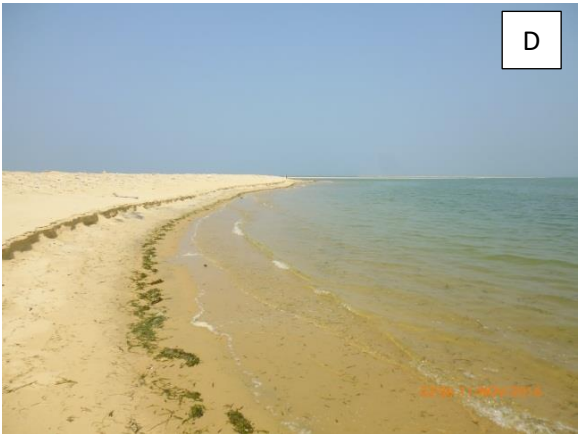
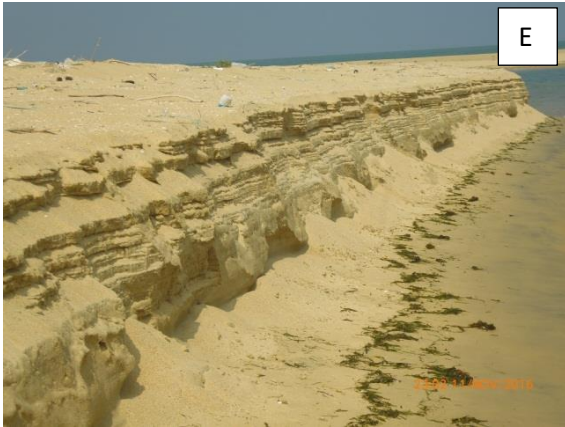
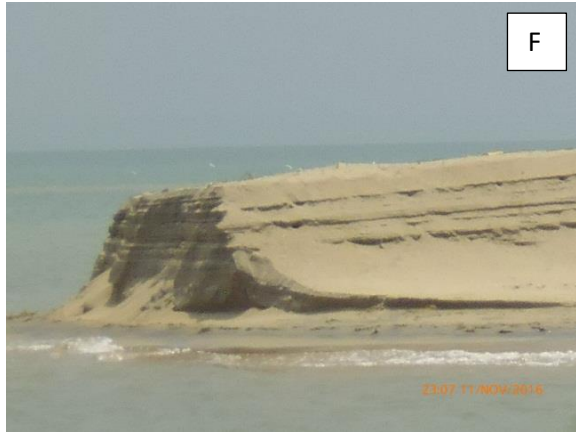
Coastal erosion along the eastern flank of the Baththalangunduwa island (Photographs A-F).

**Photographs A – F:** Eastern Margin of the Island has Eroded as Pockets by Diurnal Tidal Prism, Waves and Long Shore Currents.

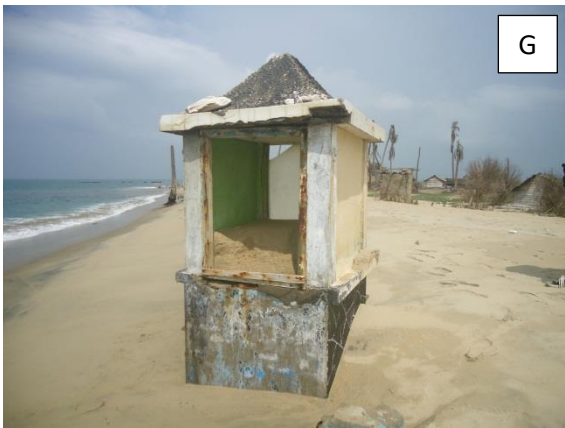
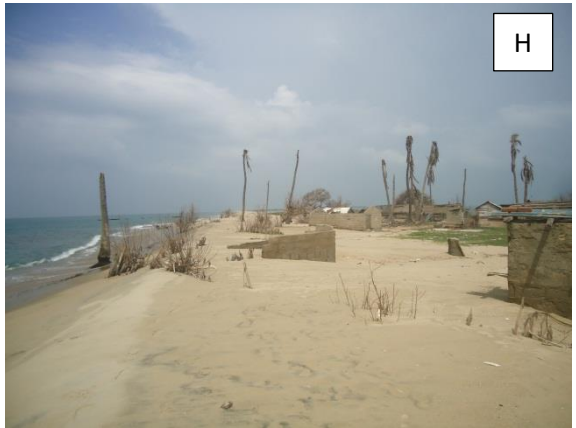
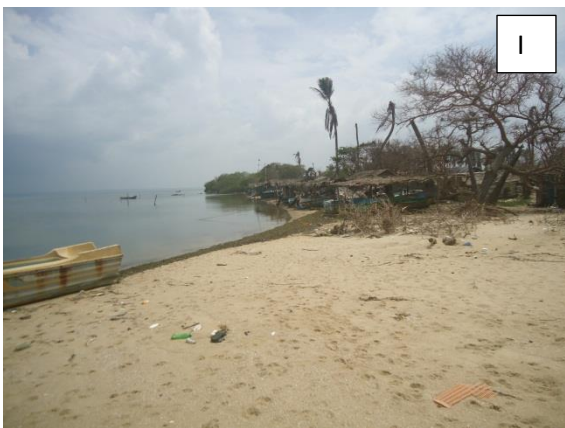
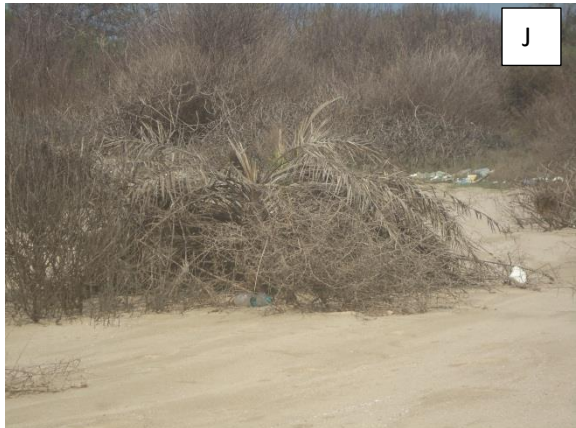
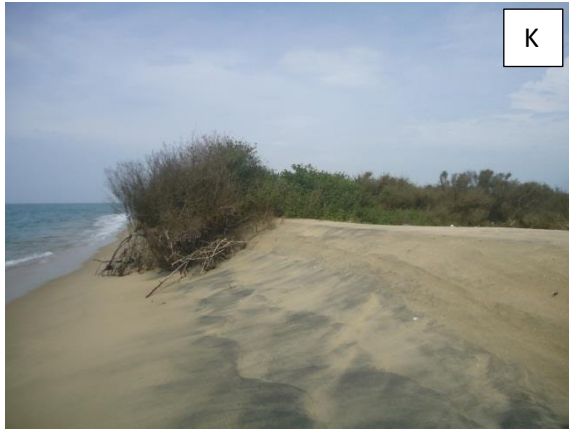
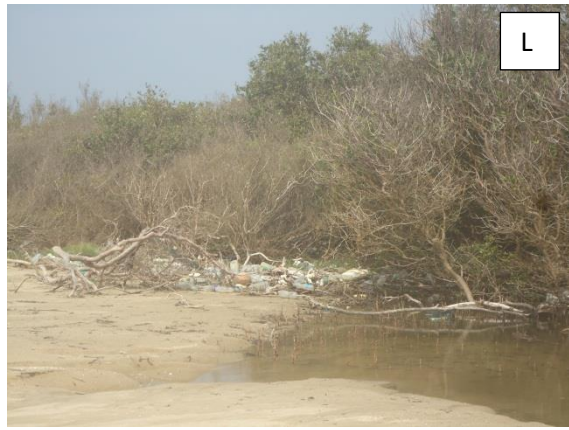
Coastal erosion along the western flank of the Baththalanguduwa island (Photographs G-L).

**Photographs G – L: Severe Erosion Along the Western Coastal Flank of the Baththalangunduwa Island by Storm Surges in 2016.**

The extension of the Baththangunduwa Island Chain is changing due to the erosion and accretion, and it is evident that the land is reducing the width annually. During our survey, we corroborated this situation with evidence through the PRA procedure held with the officials of Sri Lankan Navy Camp and the general public at the Baththalagunduwa. The elders of the Island revealed that the erosion is greater than the accretion. But we found that the eastern margin of the island has eroded as pockets by diurnal tidal prism, waves, long shore currents etc (Photographs A-F). In some years, severe erosion can be seen along the western coast and public property washed to the sea. The people
