COMPARATIVE INVESTIGATION OF GEOMORPHOLOGY BY AERIAL PHOTOGRAPH INTERPRETATION (API), DIGITAL AERIAL PHOTOGRAPH INTERPRETATION (DAPI) AND AIRBORNE LIGHT DETECTION AND RANGING (LIDAR) SURVEY: A CASE STUDY IN THE FORMER MA ON SHAN OPEN-PIT IRON MINE

Gary S. Y. FUNG and Tammy P. Y. TAM

Earth System Science Programme, 3/F Mong Man Wai Building, The Chinese University of Hong Kong, Shatin,
Hong Kong,

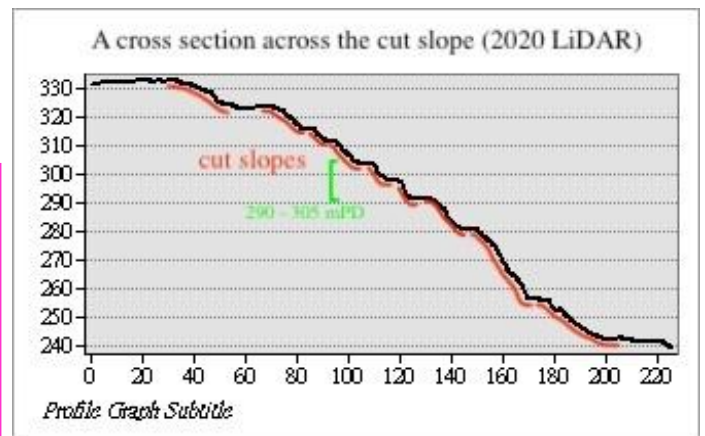
Figure 3b: Cross-section of the cut slope in 2020 LiDAR

Cut slope: The spoon-shaped cut slope is one of the key features identified in the open-pit mining site. Prior to the formation of the cut slope, the general study feature area is occupied by natural landscape. The study feature was formed as spoon-shaped cut slope in association with the construction of the open-pit mining site between 1954 and 1963 (Figure 3a). Since then, there were no observable changes apparent to the study feature except dense vegetation growth. The DAPI shows no significant different result from API. From the 2010 and 2020 LiDAR data, we can identify 9 steps in the cut slope from elevation of 330m to 245m (Figure 3b). Comparatively, the 2020 LiDAR data is more capable in showing the cut slope platforms clearly in the cross section. More details are shown in the 2020 LiDAR from 290-305 mPD, probably due to the denser point density. Field study shows no sign of instability of the cut slope.

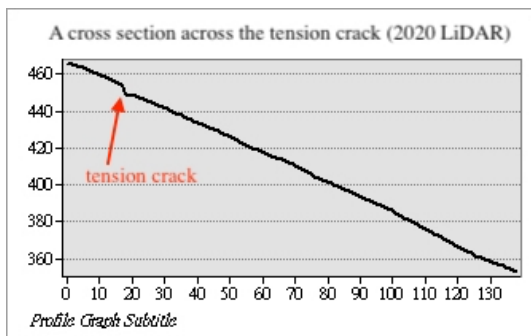
Figure 4c: Cross-section of tension crack in 2020 LiDAR

Tension Crack: An M-shape tension crack has been observed in API since 1976. The length of the tension crack is approximately 800m, in a NE-SW trending. The tension crack was obvious in the 1976 aerial photographs (Figure 4a). It fades out in the following years and can be observed again in 2000 (Figure 4b). It was last observed in 2006. Since then, there were no observable changes apparent to the study feature except vegetation growth. The DAPI shows no significant different result from API. From the 2010 and 2020 LiDAR data, we can observe a significant drop of altitude of the ground surface at an elevation of 450m. The tension crack causes the landscape dropped by 3-4 meters (Figure 4c). The 2010 and 2020 LiDAR almost show the same result on the cross-section topography of the tension crack. From the field study, it is observed that the depth of the tension crack is approximately 3m (Figure 4d). It coincides with the result of LiDAR. The scarp of the crack consists of mainly sub-angular cobbles and boulders with a diameter of 0.2m.

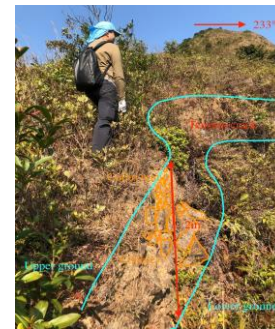
Figure 4d: Field photography of the tension crack

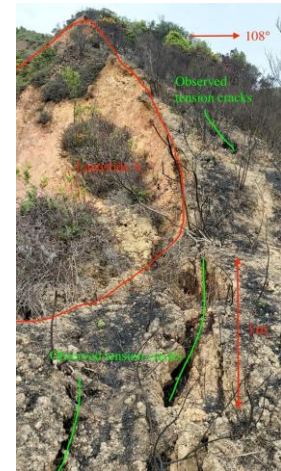
Figure 5d: Field Photograph of Landslide A

Landslide A: Landslide A was first discovered as 3 landslides in 1963 (Figure 5a), possibly due to open-pit mining activities. In 1976, the landslides enlarged and combined into a triangular-shaped landslide - Landslide A (Figure 5b). There was an obvious change in the location for landslide A. It has been retreated backward reaching the ridge in the subsequent years. Since 1997, there were no observable changes apparent to the study feature except dense vegetation growth. From the DAPI, it is observed that there is a significant change of location for Landslide A. By tracking the upper edge of the landslide, it is discovered that the landslide has retreated 120 m in the past 50 years (Figure 5c). From the 2010 and 2020 LiDAR data, we can observe the surface of rupture at an elevation of 470m - 430m. There is accumulation of debris at an elevation of 430m - 420m. The 2010 and 2020 LiDAR almost show the same result on the cross-section topography of Landslide A, indicating that there is no obvious change in extent or morphology of the landslide between those 10 years. The bare slope surface with no vegetation growth observed in field study indicates erosion activities. The tension cracks are subparallel to one of the slope faces of Landslide A (Figure 5d).

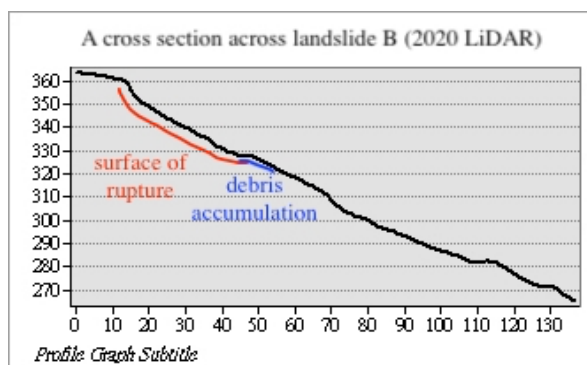
Figure 6c: Cross-section of Landslide B in 2020 LiDAR

Landslide B: Landslide B was observed since 1963 in association with the construction of cut slope (Figure 6a). Significant slope failure has occurred in 1963 to 1976. Since then, there were no observable changes apparent to the study feature except vegetation growth. From the DAPI, it is observed that there is a minor change of location for Landslide B. Landslide B has retreated around 5 meters backward in the past 50 years (Figure 6b). From the 2010 and 2020 LiDAR data, we can observe the surface of rupture at an elevation of 360m - 330m. There is accumulation of debris at an elevation of 330m - 325m (Figure 6c). The 2010 and 2020 LiDAR almost show the same result on the cross-section topography of the tension crack. From the field study, due to the limitation of accessibility, we cannot walk close to Landslide B for slope evaluation. It is observed that part of Landslide B is covered by vegetation, however, there are many loose rock fragments on the slope, which indicates the occurrence of past instability of the slope (Figure 6d).

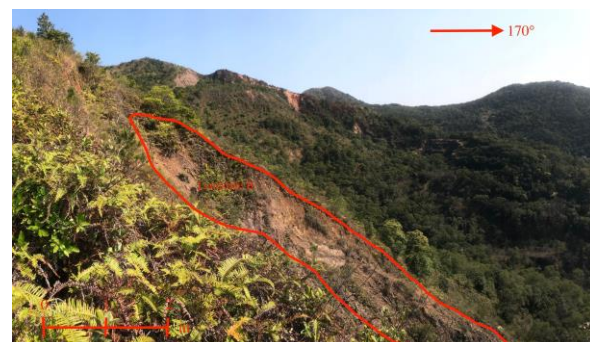
Figure 6d: Field Photograph of Landslide B
